**UNDERWATER FACILITIES  
INSPECTIONS  
AND  
ASSESSMENTS  
AT**

**NAVAL STATION  
MAYPORT, FLA.**

**JULY 1980**

**CHILDS ENGINEERING CORPORATION  
MEDFIELD, MASSACHUSETTS 02052**

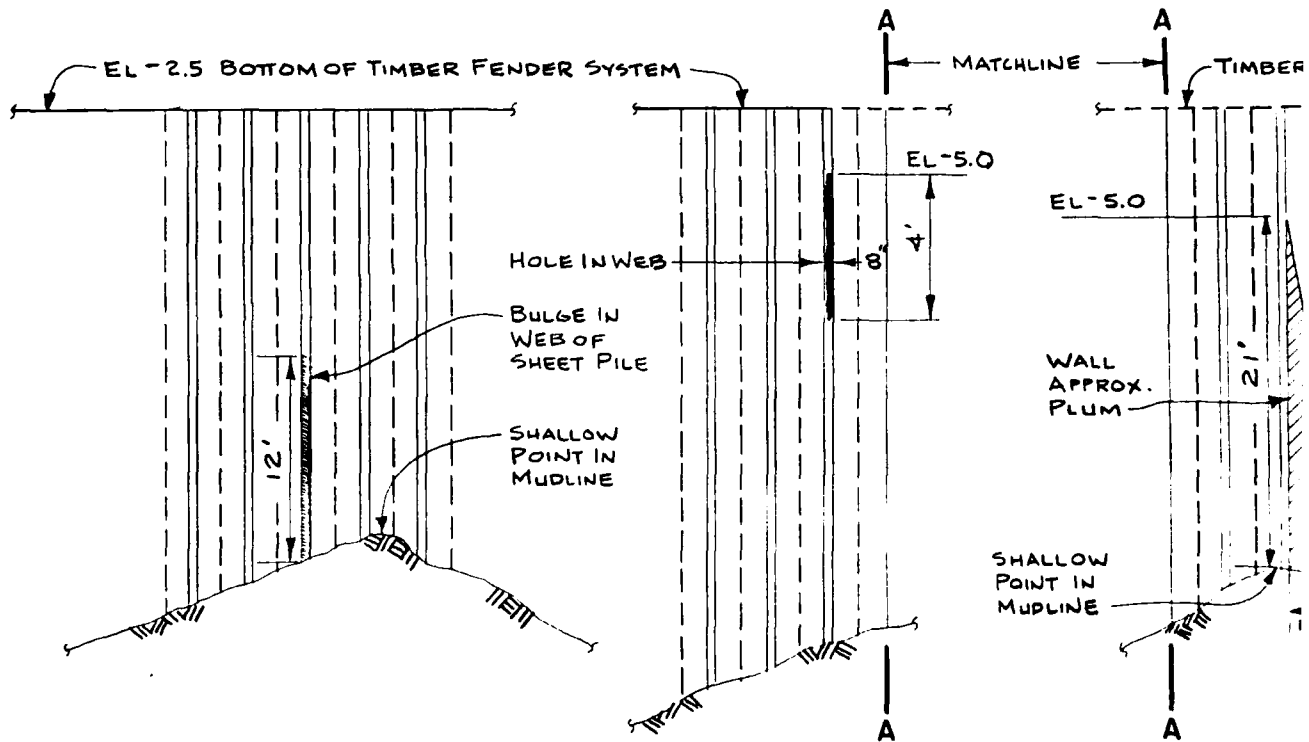
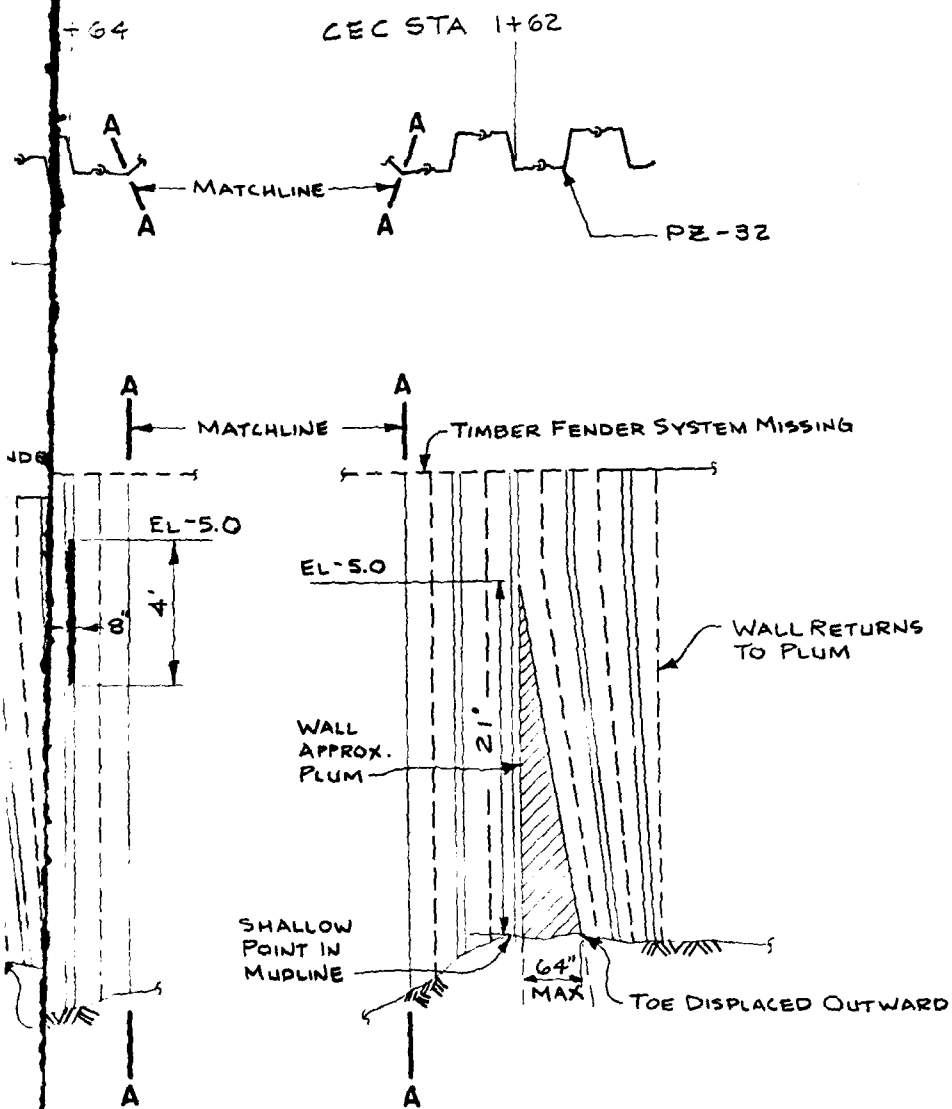
GRAPHIC SCALE	Childs Engineering Corporation Box 353, Needham, MA	CHESAPEAKE DIVISION NAVAL FACILITIES ENGINEERING COMMAND Seaside, N.C.	
NOT TO SCALE		NAVAL STATION BULKHEAD EAST OF CARRIER BERTH C-2	FIG. 15

- 1) At CEC Sta. 2+07, the web of this pile is distorted (bulged out) from the mudline up 12';
- 2) At CEC Sta. 1+64, a hole, 8" wide x 4' high (top el. -5.0') was found in the web;
- 3) At CEC Sta. 1+62, a rip was observed at the web/flange intersection in the first Z section sheet pile just east of the corner pile (see Photo #9). It originated at el. -5.0' and continued to mudline (21' long). A maximum displacement of 64" was measured at the mudline. The side east of the rip was displaced outward with respect to the side west of the rip. Mounding of the sandy granular fill extended 10' away from the wall before the bottom became silty.
